Chippewa Lake Weed Control District Advisory Committee Report

May 3, 2024

2023 Team Monitoring

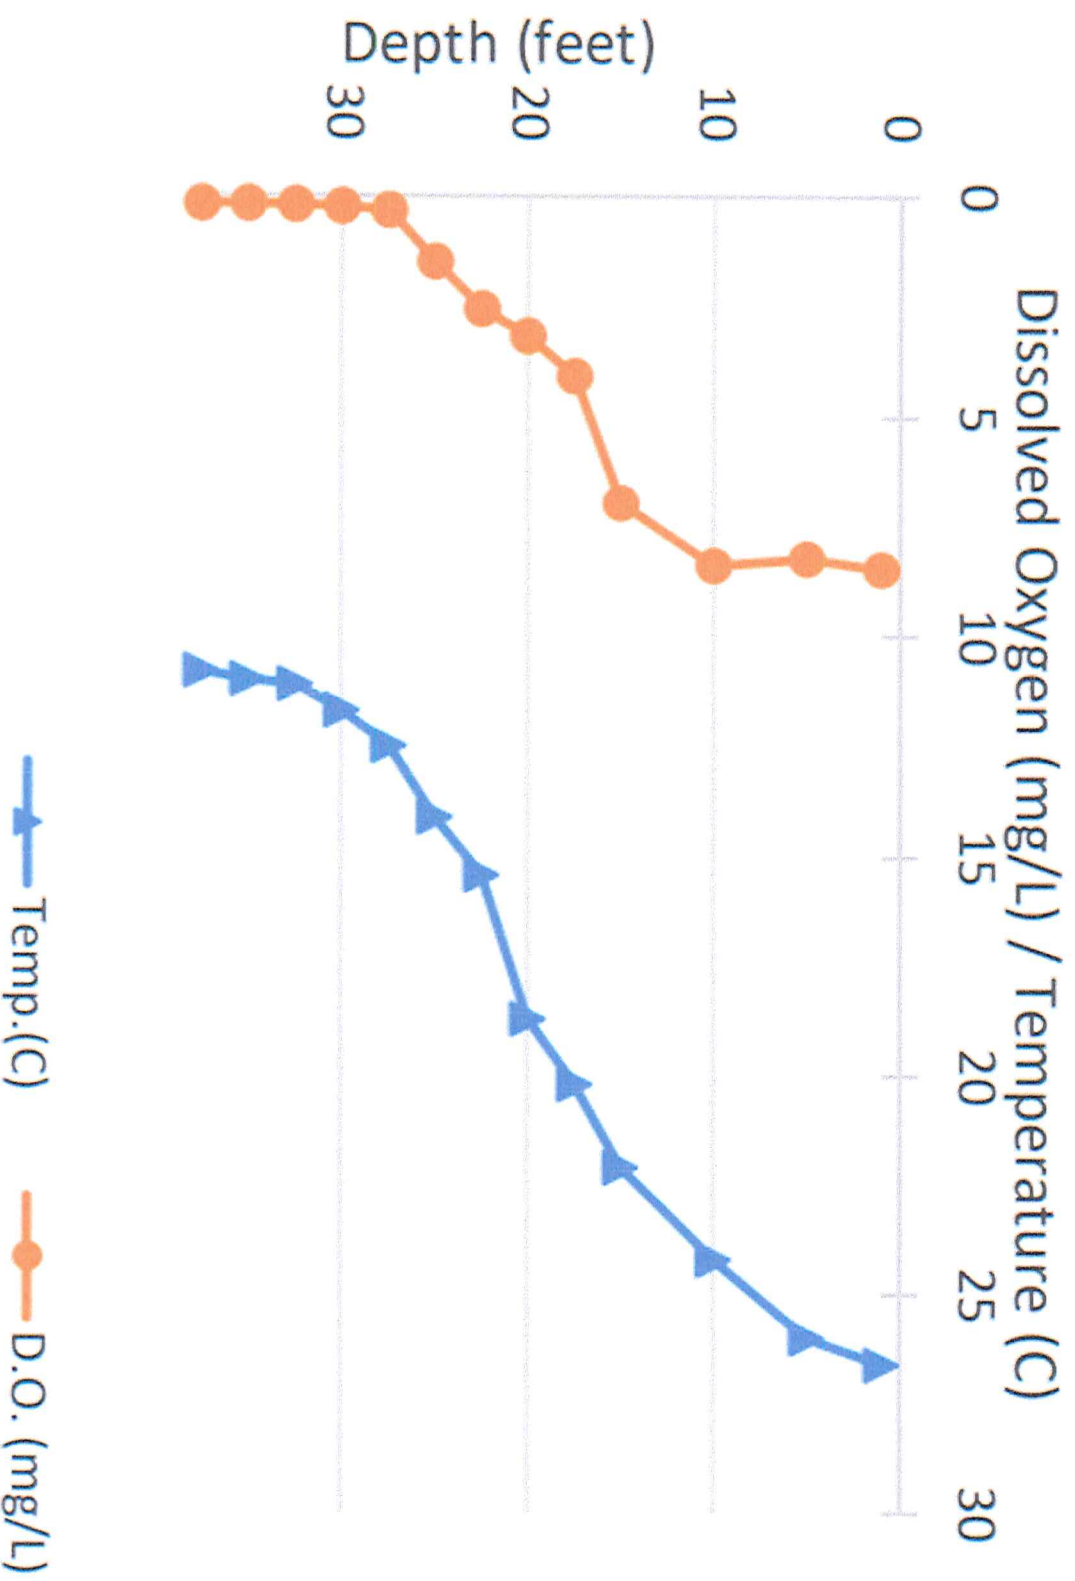
Dissolved Oxygen and Temperature Profile

7/2/23

The lake keeps some dissolved oxygen in the bottom waters through early summer, but by mid-summer the lake has stratified and the bottom water is devoid of oxygen.

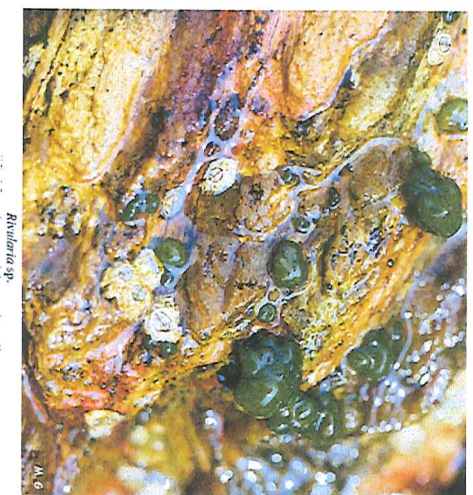
Rivularia Alga

Identified in Chippewa Lake in 2023

Can be transported from lake to lake easily, even through the air

Can be dormant for many years

It is classified as a blue/green alga (but different)
